**FOURTH FIVE-YEAR REVIEW REPORT FOR  
PINETTE'S SALVAGE YARD SUPERFUND SITE  
AROOSTOOK COUNTY, MAINE**

**U.S. Environmental Protection Agency  
Region 1  
Boston, MA**

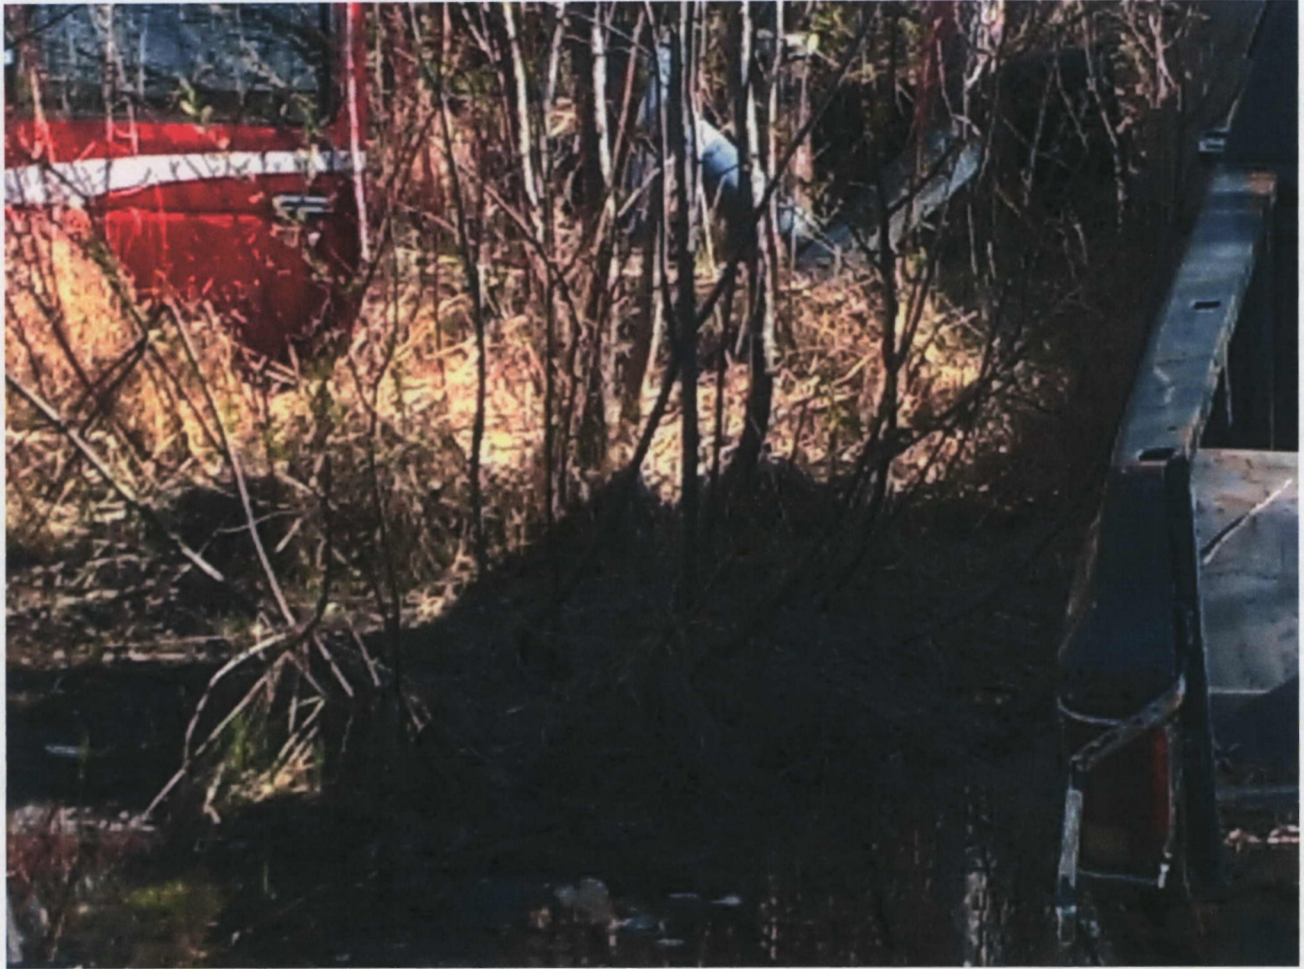
**Photo #1. MW-1 Well Cluster (Access is impeded by standing water, junked vehicles, and vegetation, and bollards are no longer vertical). May 2015.**

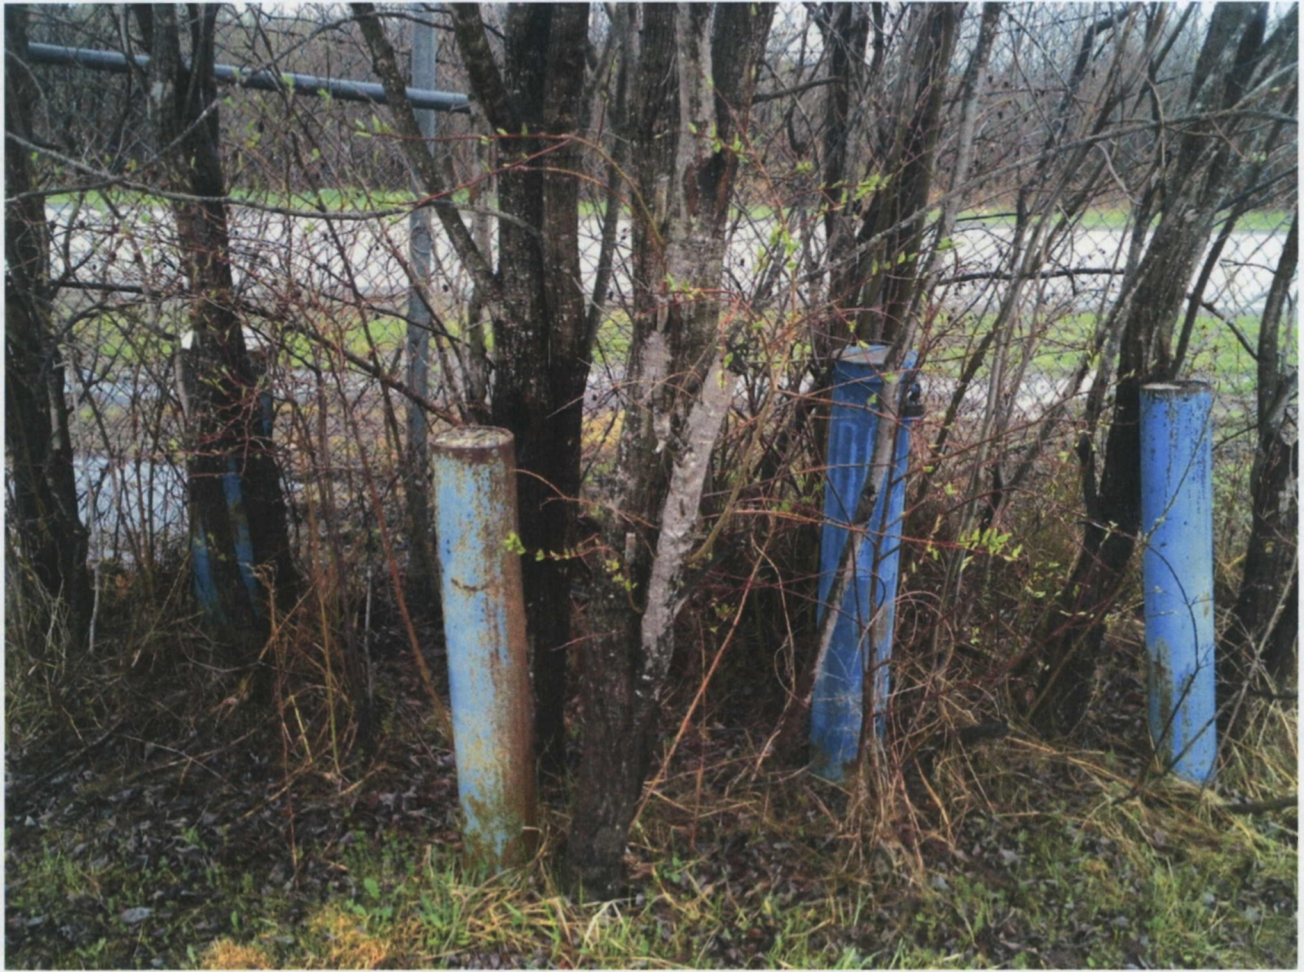
**Photo #2. MW-2 Well Cluster. May 2015.**

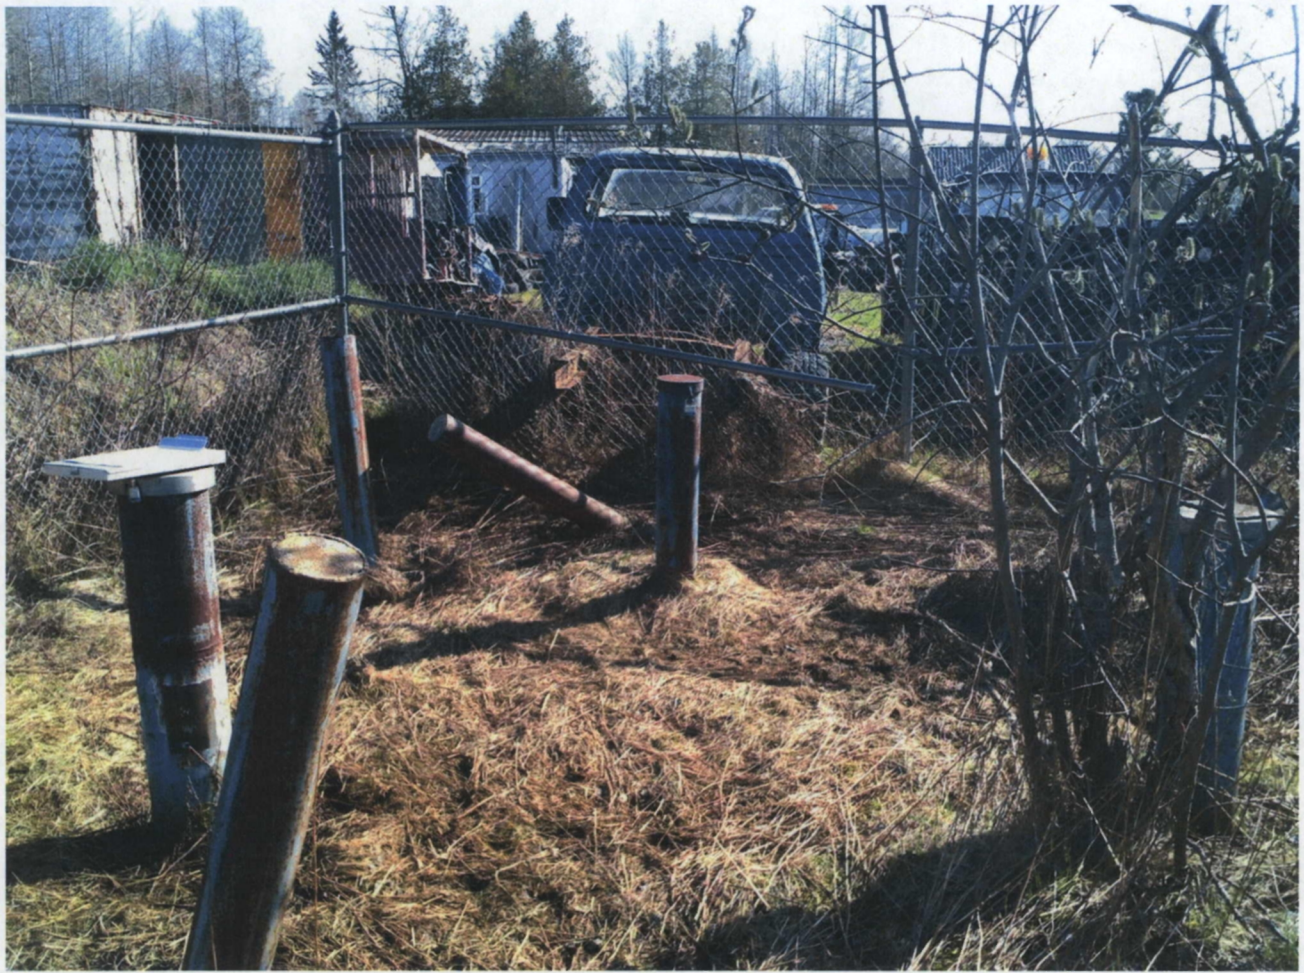
Several fence-related issues that had been noted in the 2009 Site inspection were again noted in 2015. For example, one side of the fence that surrounds the MW-5 well cluster has a bent vertical post, and the horizontal support pipes (middle and top of fence) are no longer connected to the posts in several locations. However, the fence remains effective at limiting access to those wells, since the chain link fabric is intact. Also, sections of the fence that were built around much of the Site during the soil remediation were removed prior to 2009. As a result, 1) there is no fence on the northeast side of the Site between the MW-2 well cluster and the garage; 2) the fence that once crossed the dirt road that runs northwest from the MW-8 well cluster is gone; and 3) a relatively small gap exists in the chain link fabric between two adjacent vertical fence posts in the extreme western corner of the fenced area. Most of the fence along Gardner Creek Road is intact, as is the gate near the former MW-4 well cluster. Since only the fence around the MW-5 well cluster is subject to the Restrictive Covenant, the removals of sections of the perimeter fencing were not violations of that document.

**Photo #3. MW-5 Well Cluster (Note damage to horizontal support pipes in fence). May 2015.**

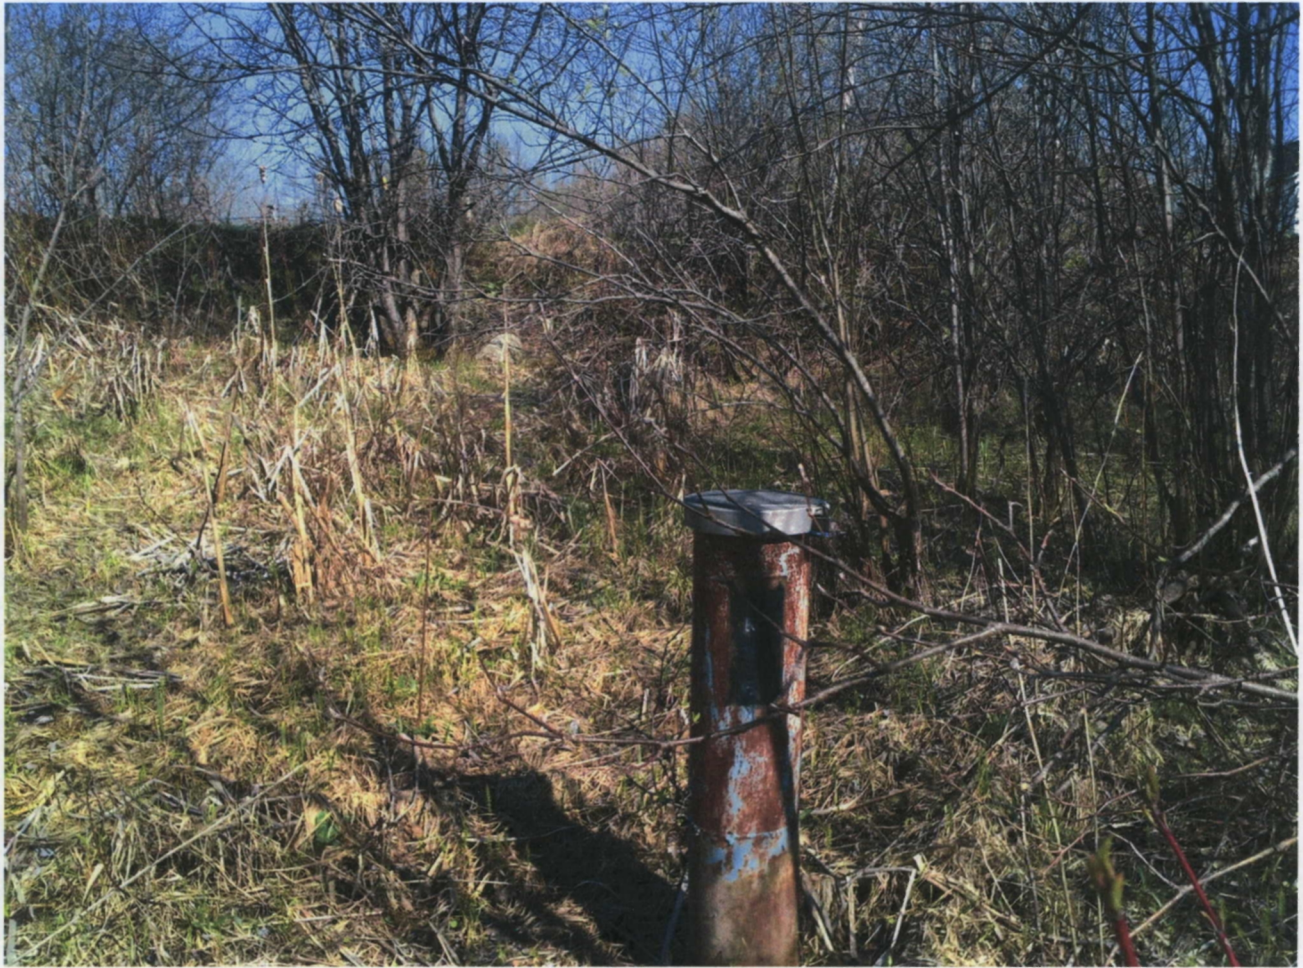
**Photo #4. Well DMW-6. May 2015.**

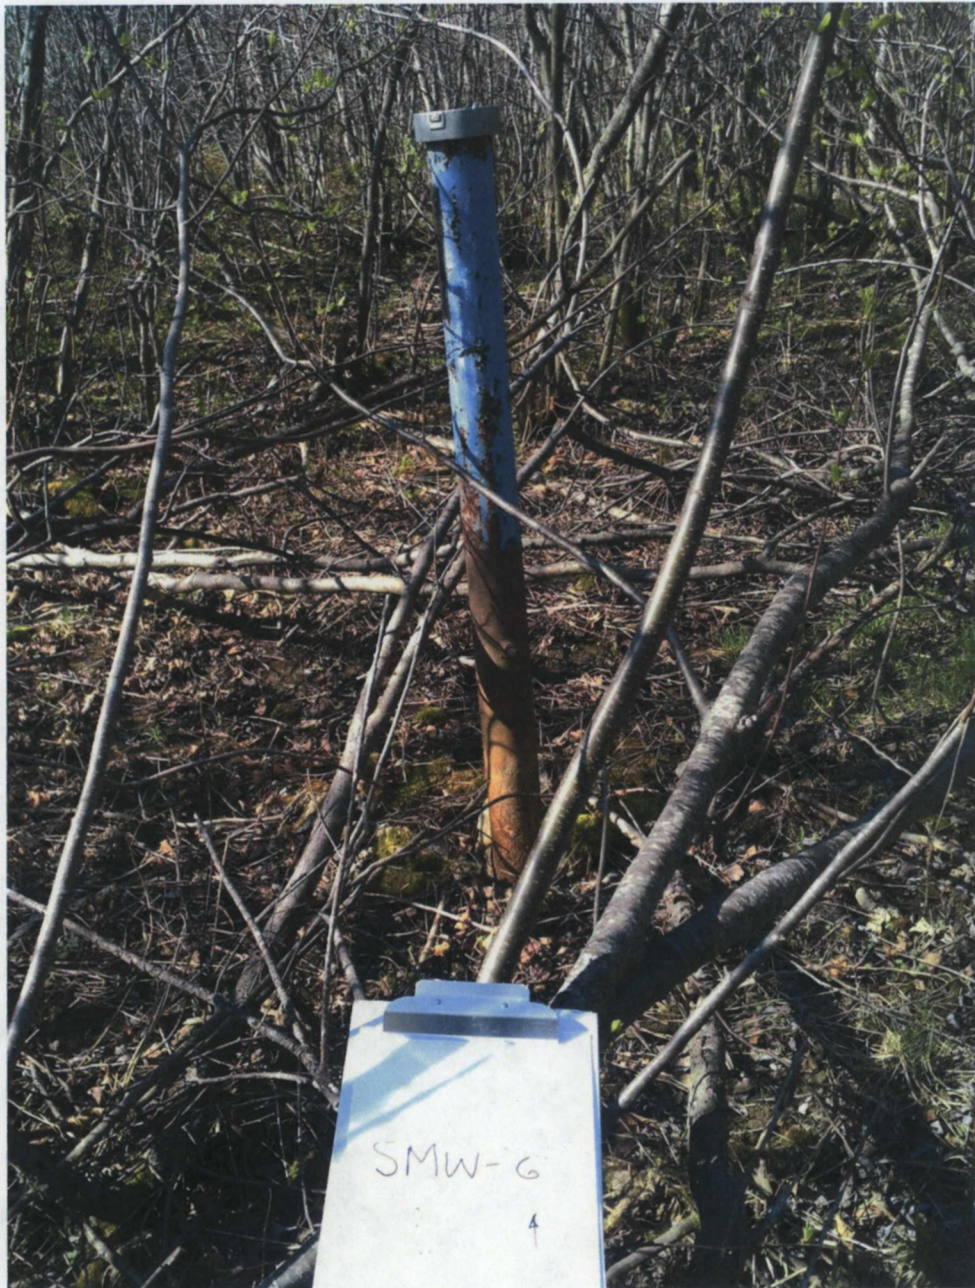
**Photo #5. Well SMW-6 (Protective casing appears to have been thrust upwards). May 2015.**

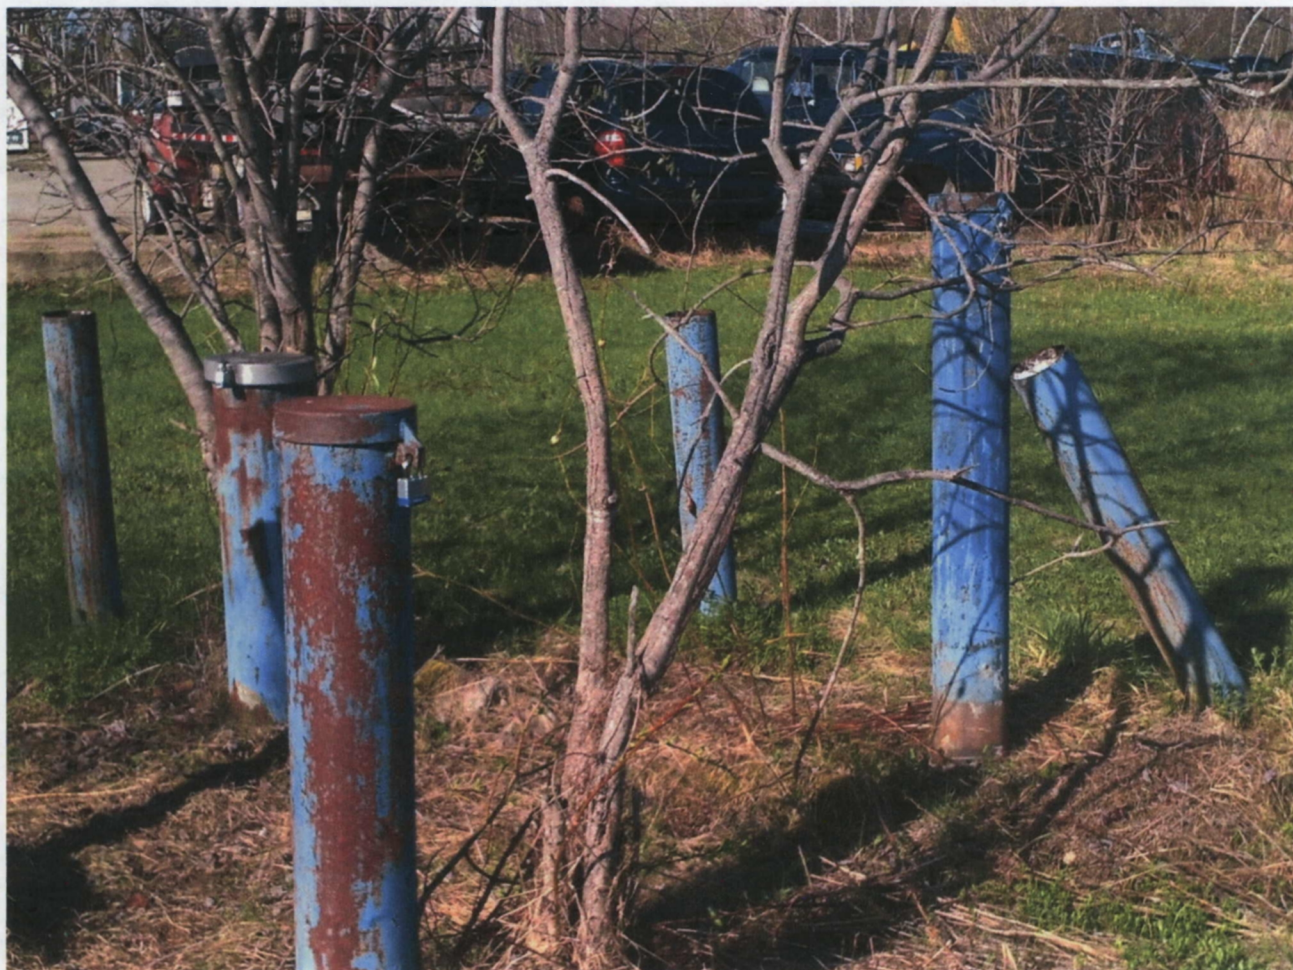
**Photo #6. MW-7 Well Cluster (Western part of Restricted Area, showing vehicles parked on concrete pad). May 2015.**

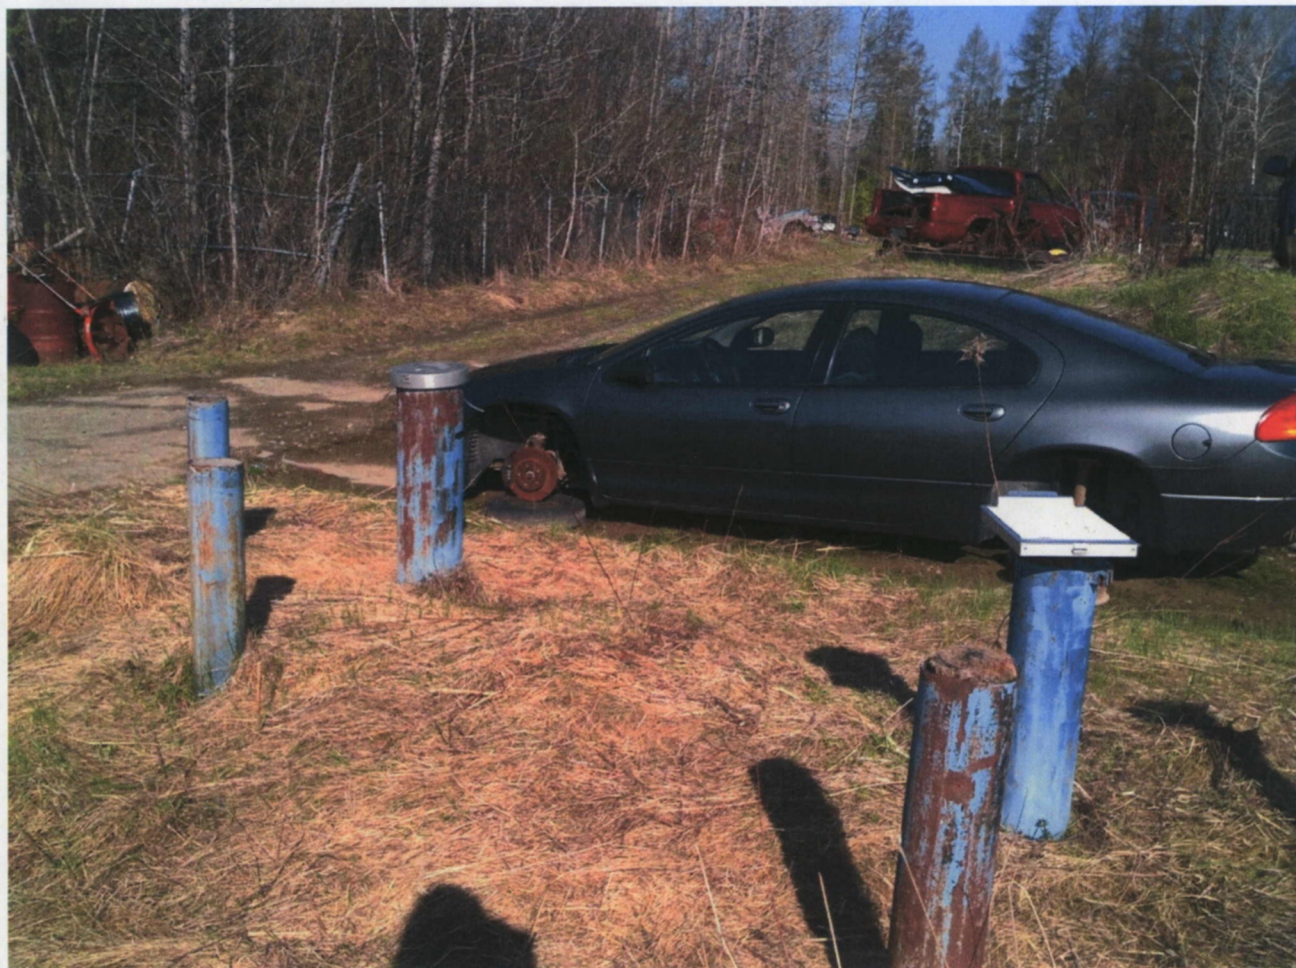
**Photo #7. MW-8 Well Cluster. May 2015.**

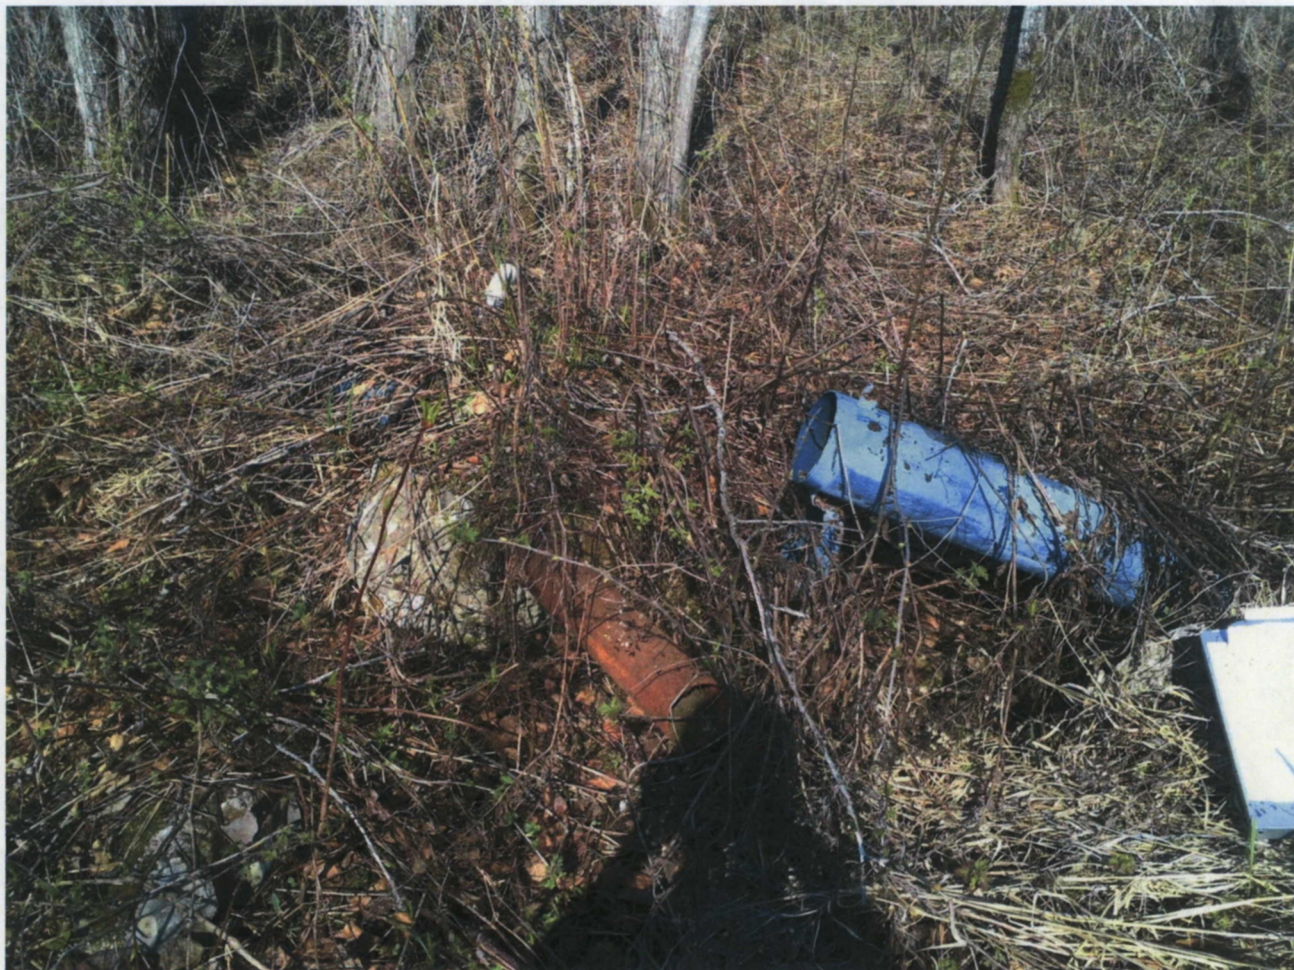
**Photo #8. Remnants of MW-9 Well Cluster (Destroyed about 15 years ago). May 2015.**

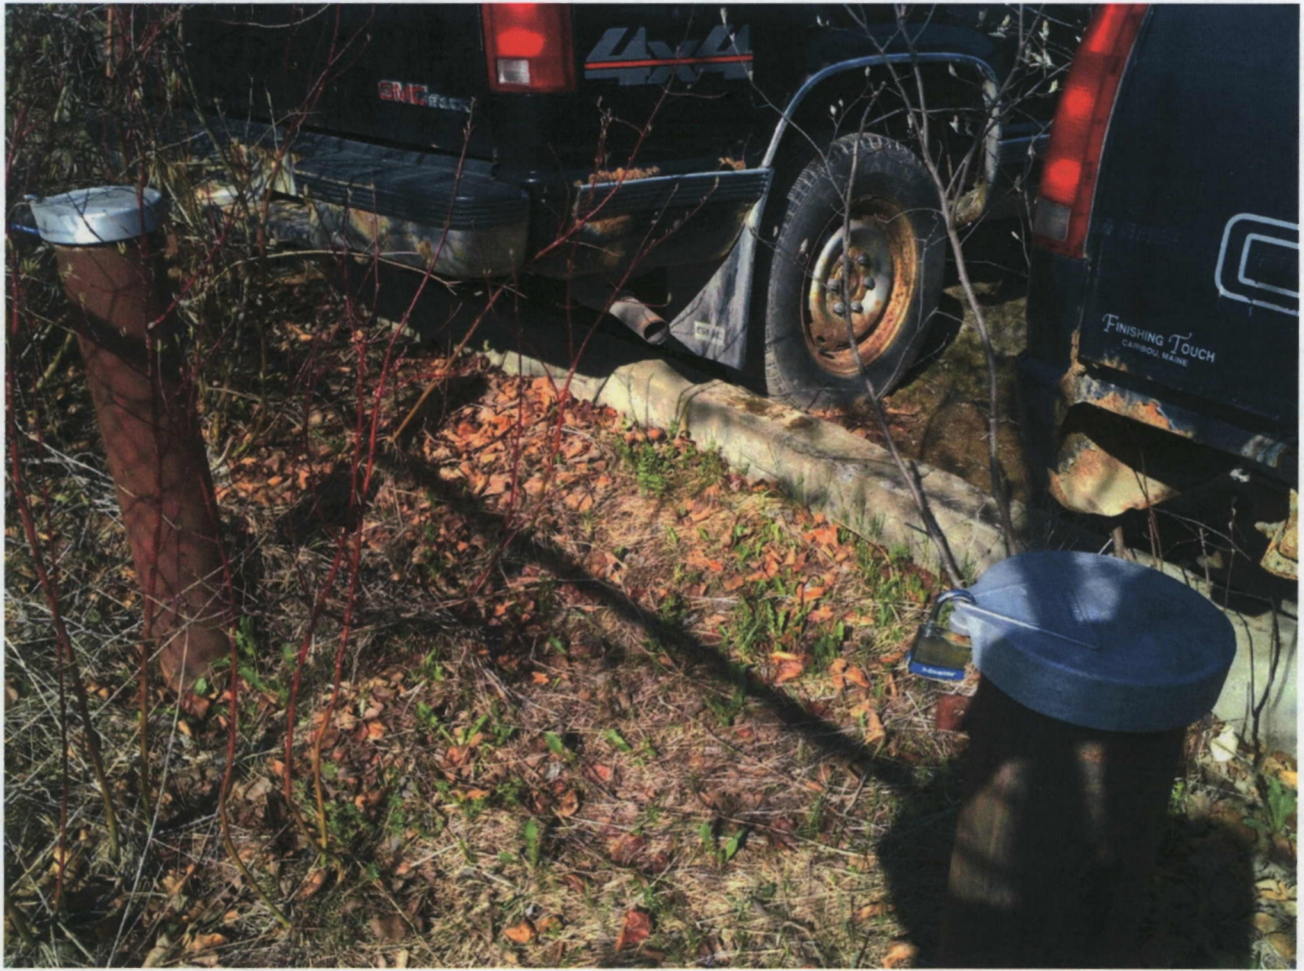
Photo #9. MW-10 Well Cluster. May 2015.

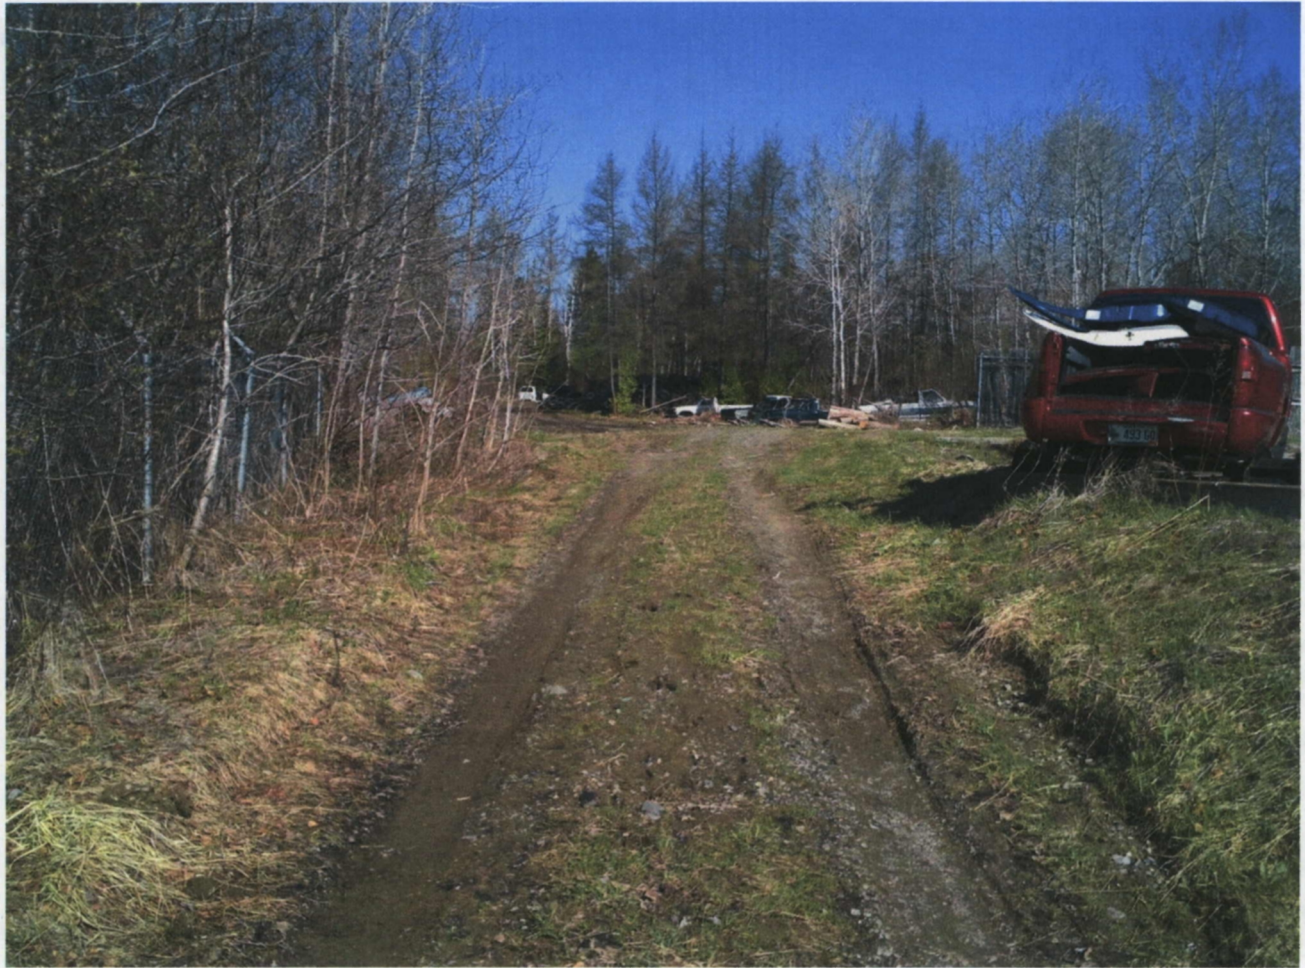
**Photo #10. View to the Northwest from near the MW-8 Well Cluster (Note tire pile in background, outside Restricted Area). May 2015.**

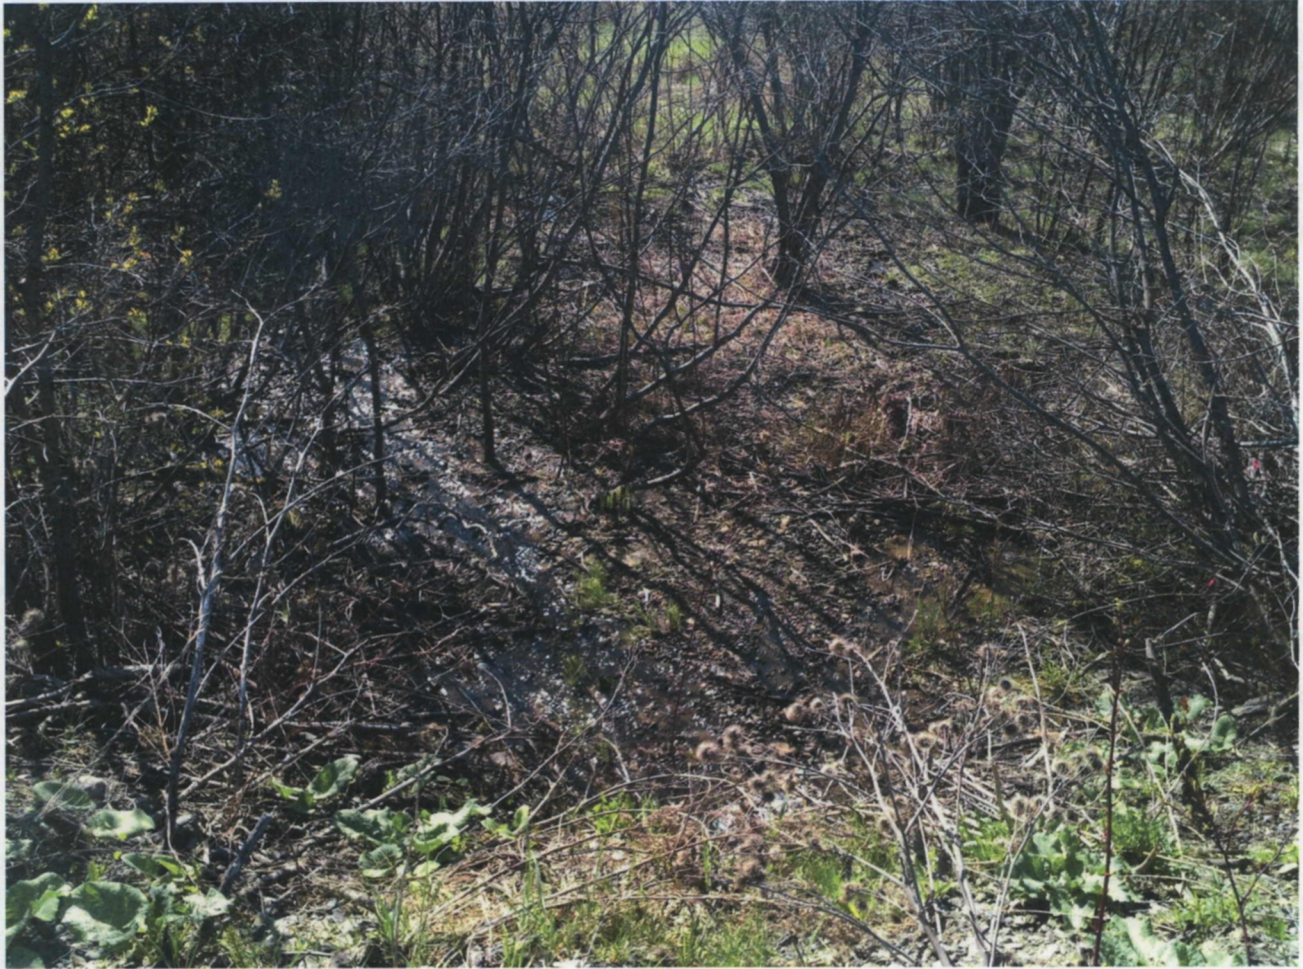
**Photo #11. Groundwater Breakout Area (On east side of Gardner Creek Road). May 2015.**

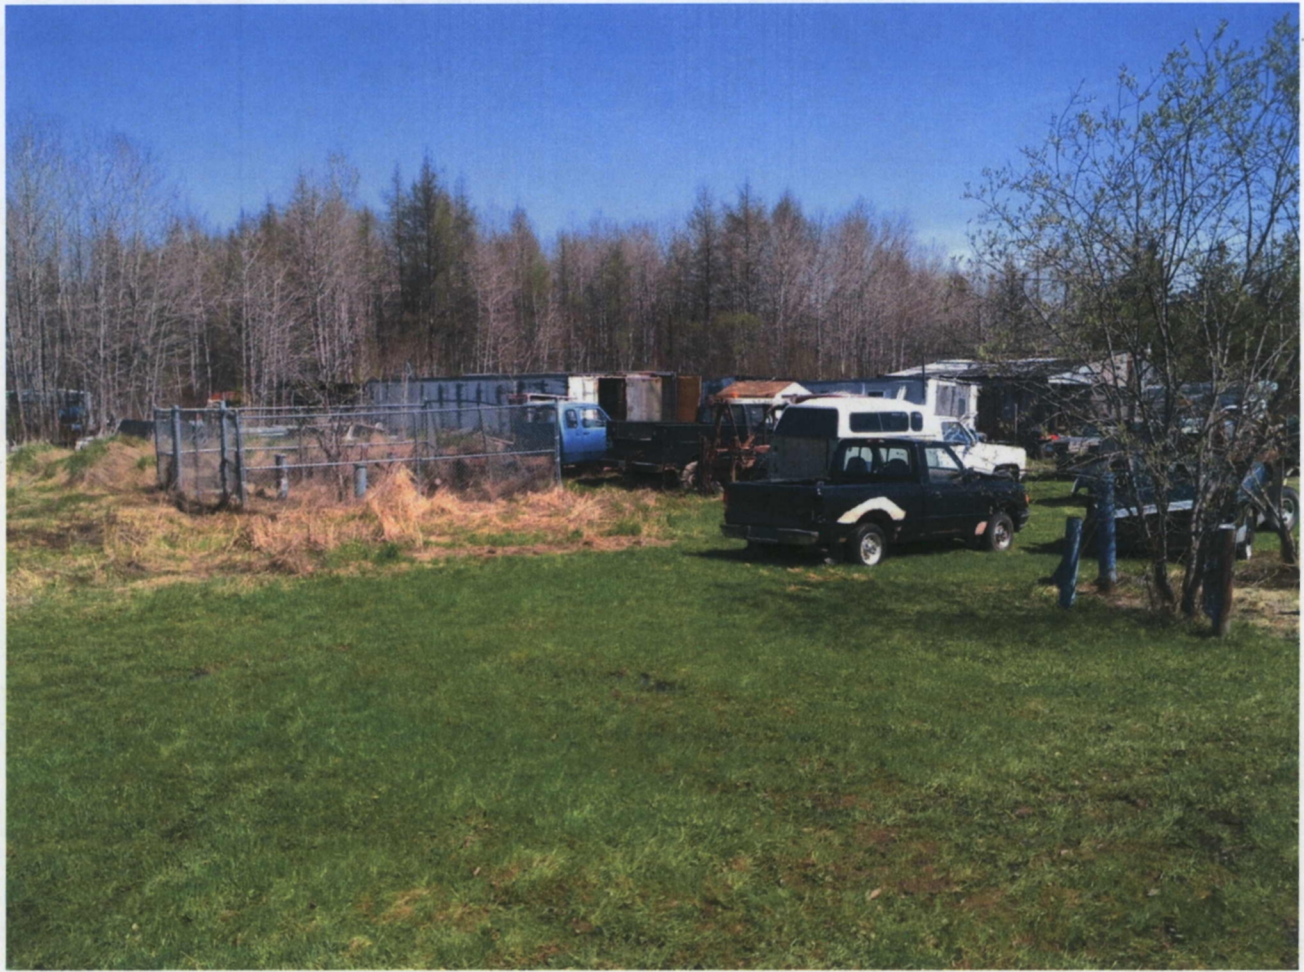
**Photo #12. View of Restricted Area (Looking north past MW-5 and MW-7 Well Clusters, garage visible in background above MW-7 Cluster). May 2015.**

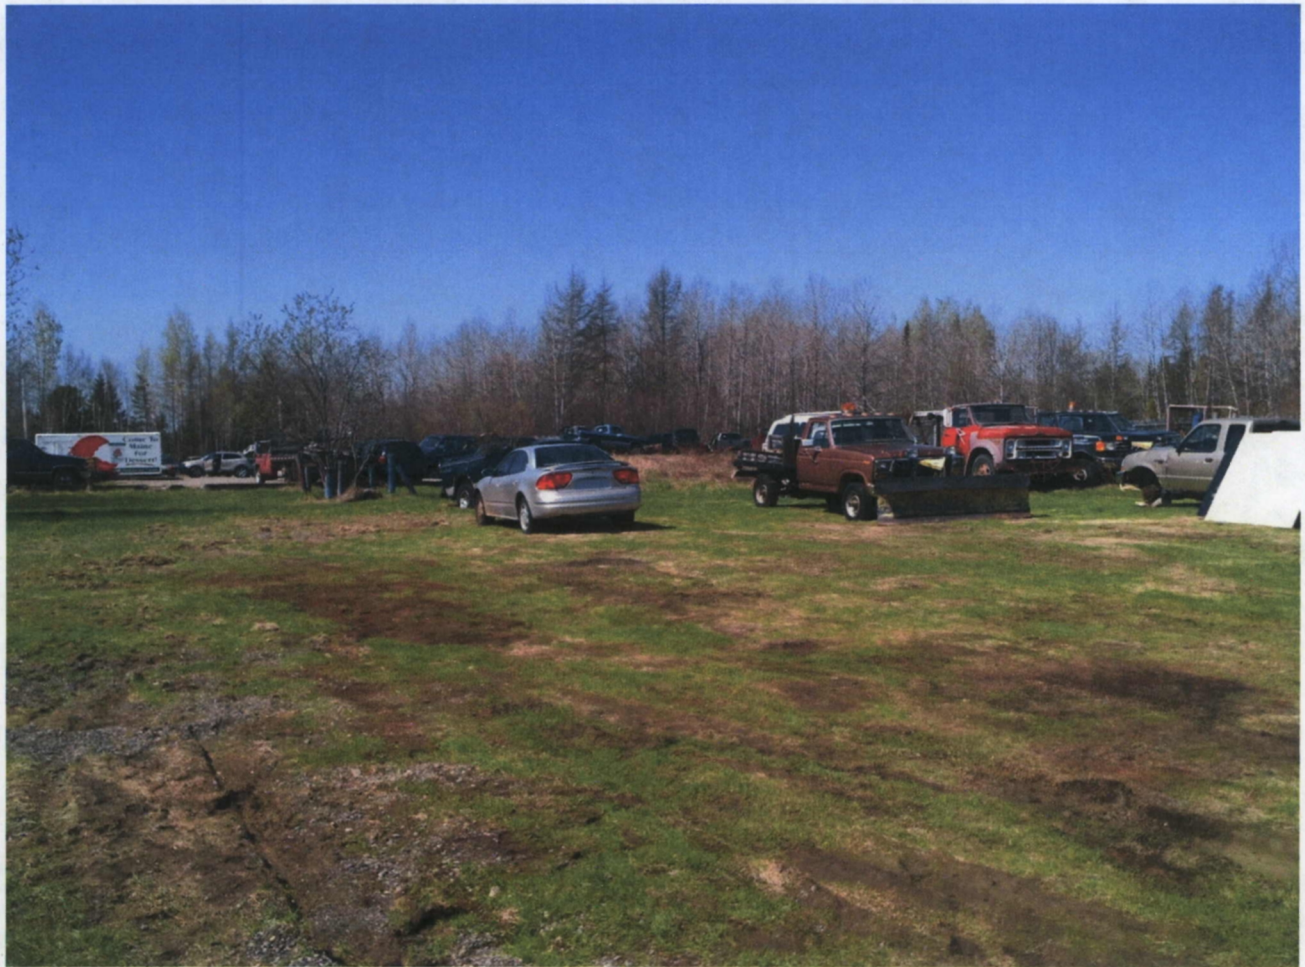
**Photo #13. View of Restricted Area (Looking west toward MW-7 Well Cluster; MW-5 Well Cluster is behind trucks on right side of photo). May 2015.**

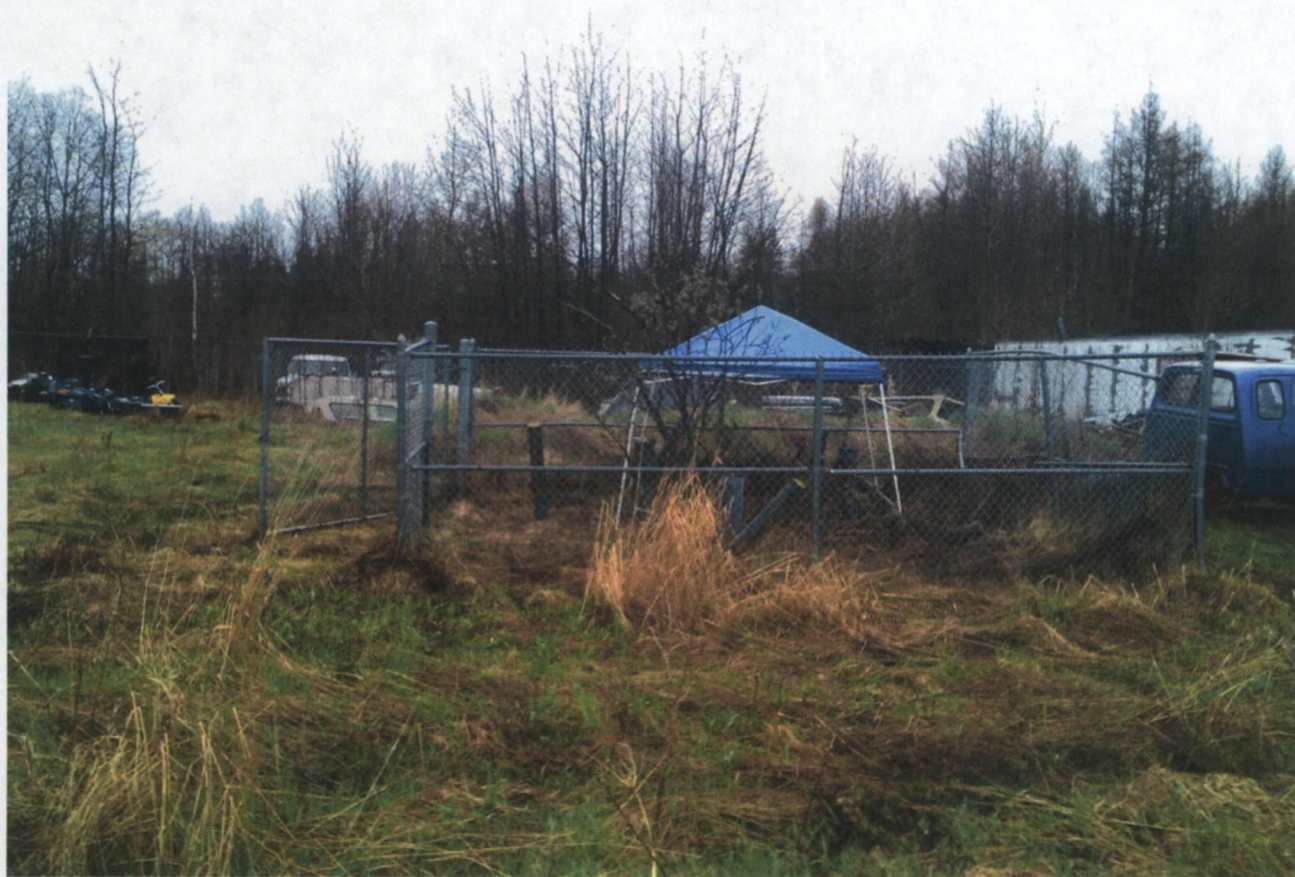
**Photo #14. MW-5 Well Cluster (Note minor damage to fence on right side, partly open undamaged gate on left side). May 2015.**

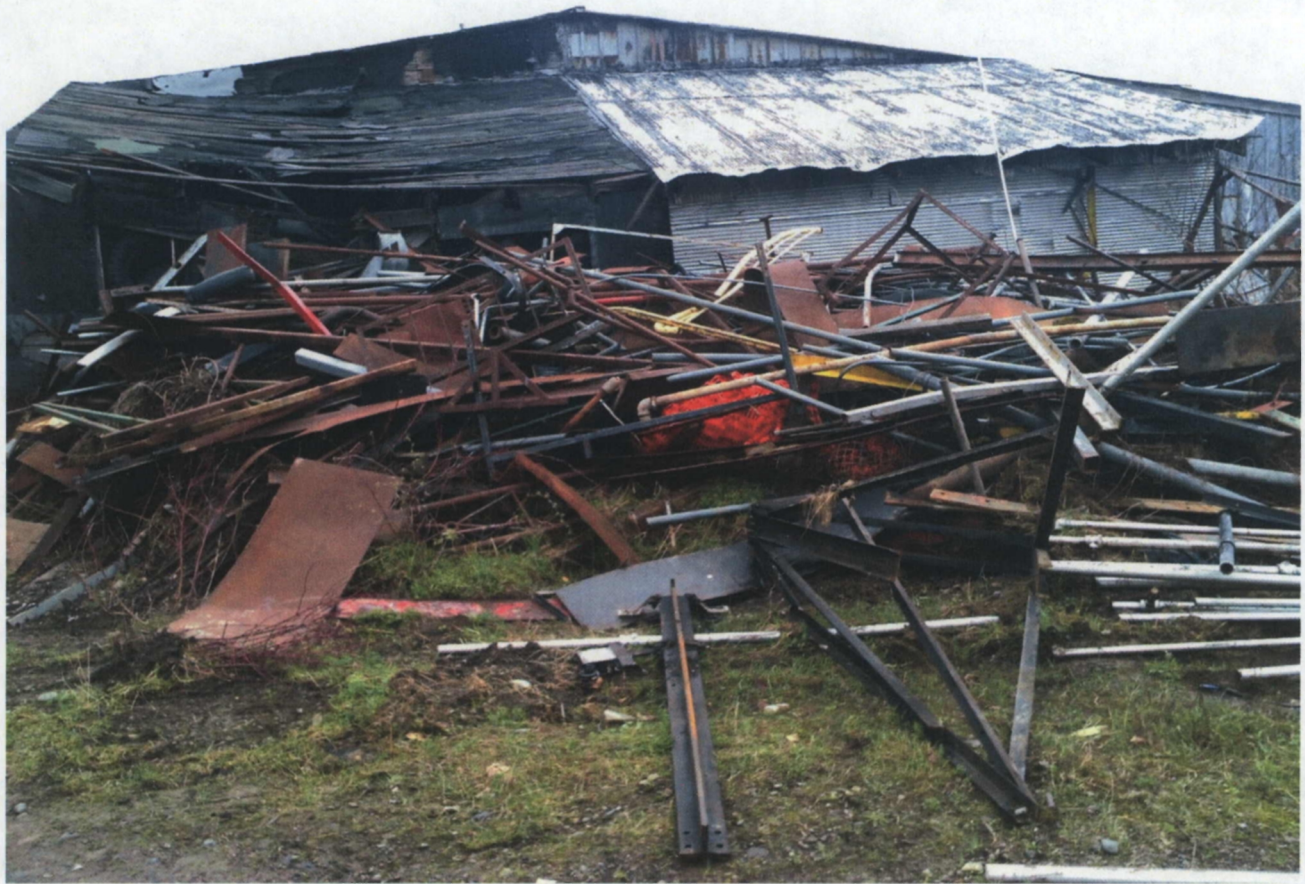
**Photo #15. Scrap metal pile behind garage (Just outside of Restricted Area). May 2015.**

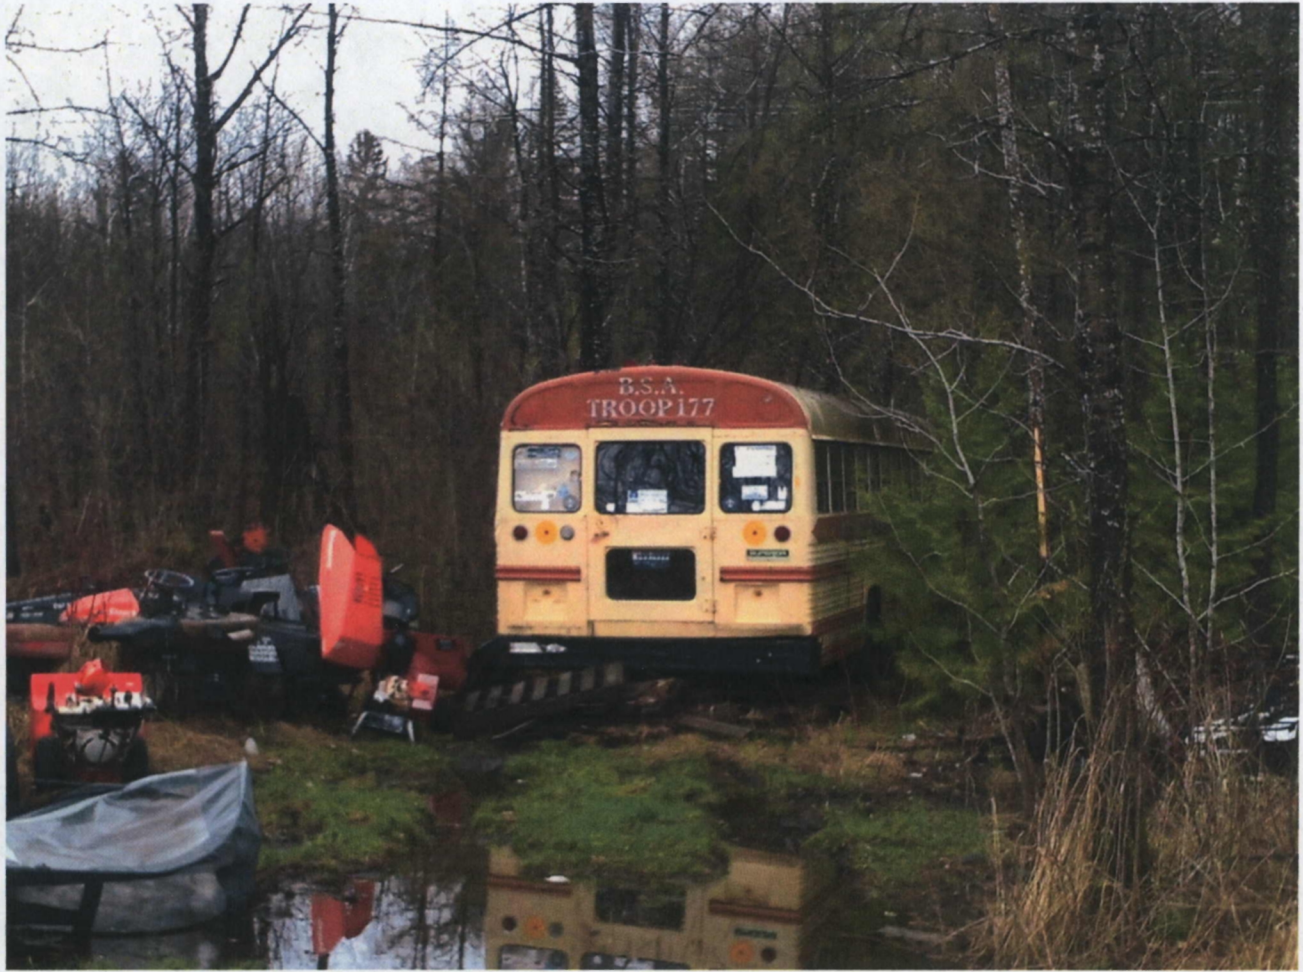
**Photo #16. Salvaged items north (outside) of Restricted Area (note standing water in foreground). May 2015.**
